# **Condition Assessment of Levees, U.S. Section of the International Boundary and Water Commission**

Report 5

Flood Simulation Study of Retamal Levee, Lower Rio Grande Valley, Texas, Using  
Seismic and Electrical Geophysical Models

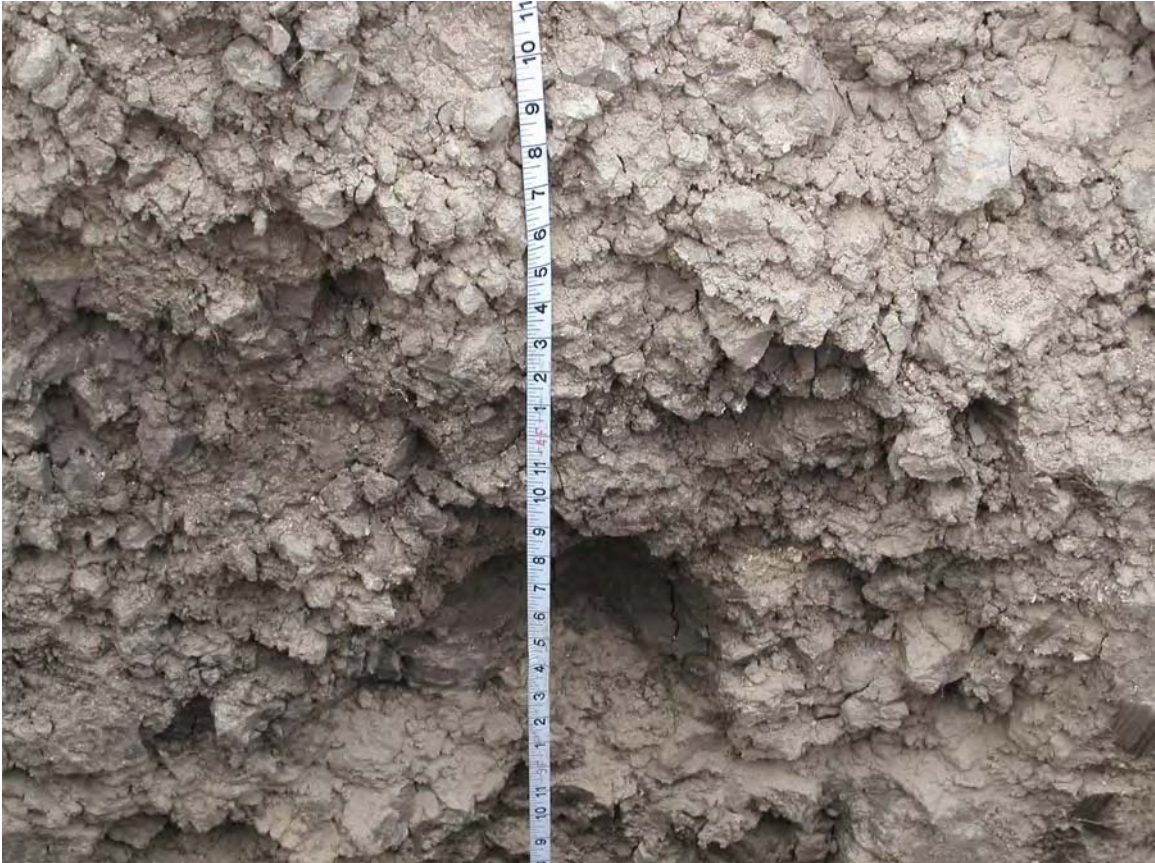
Figure 4. Close-up view looking west at cracked, blocky clay texture at RS 5, depth from about 2 to 3 ft.

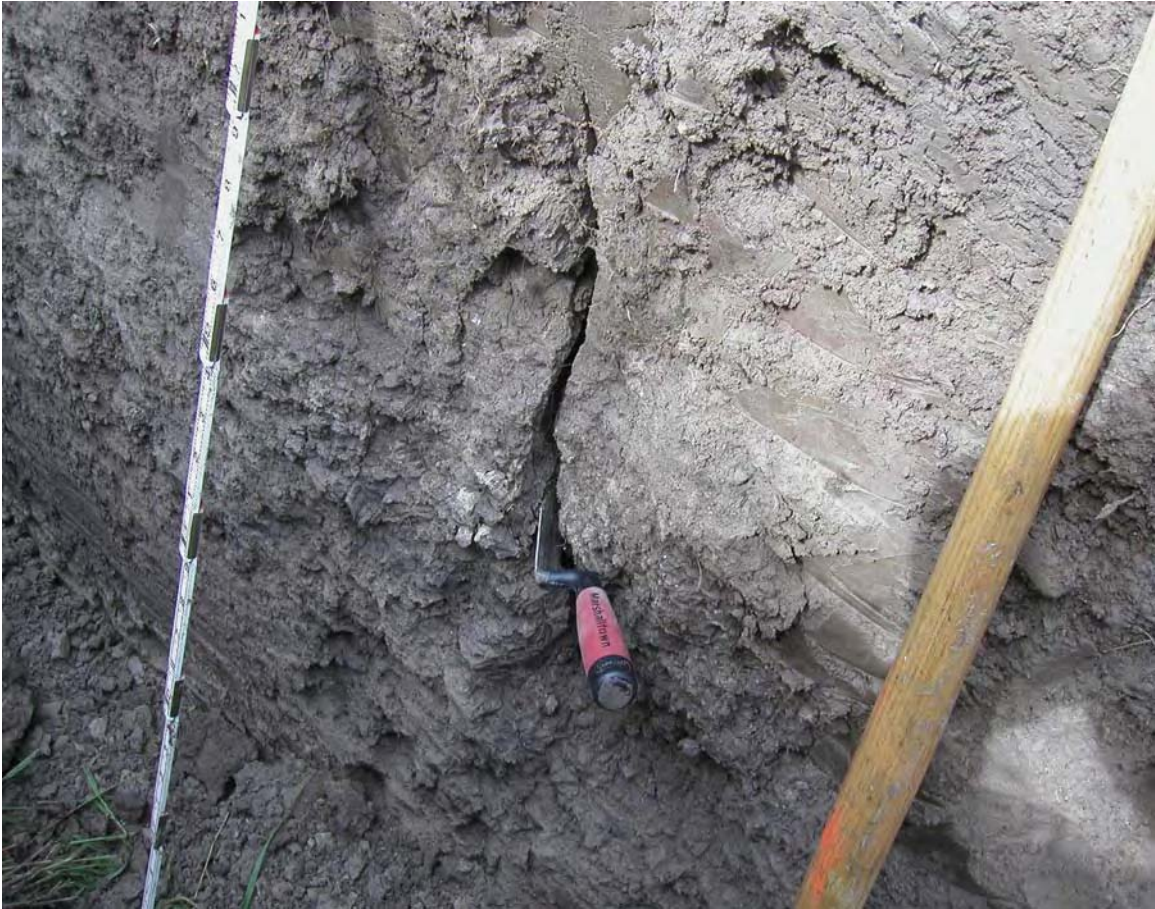
Figure 5. View looking west at profile LS 25 showing crack extending from 2.2 to 3.7 ft, note trowel in vertical crack ranging from  $\frac{1}{4}$  to  $\frac{1}{2}$  in. wide.

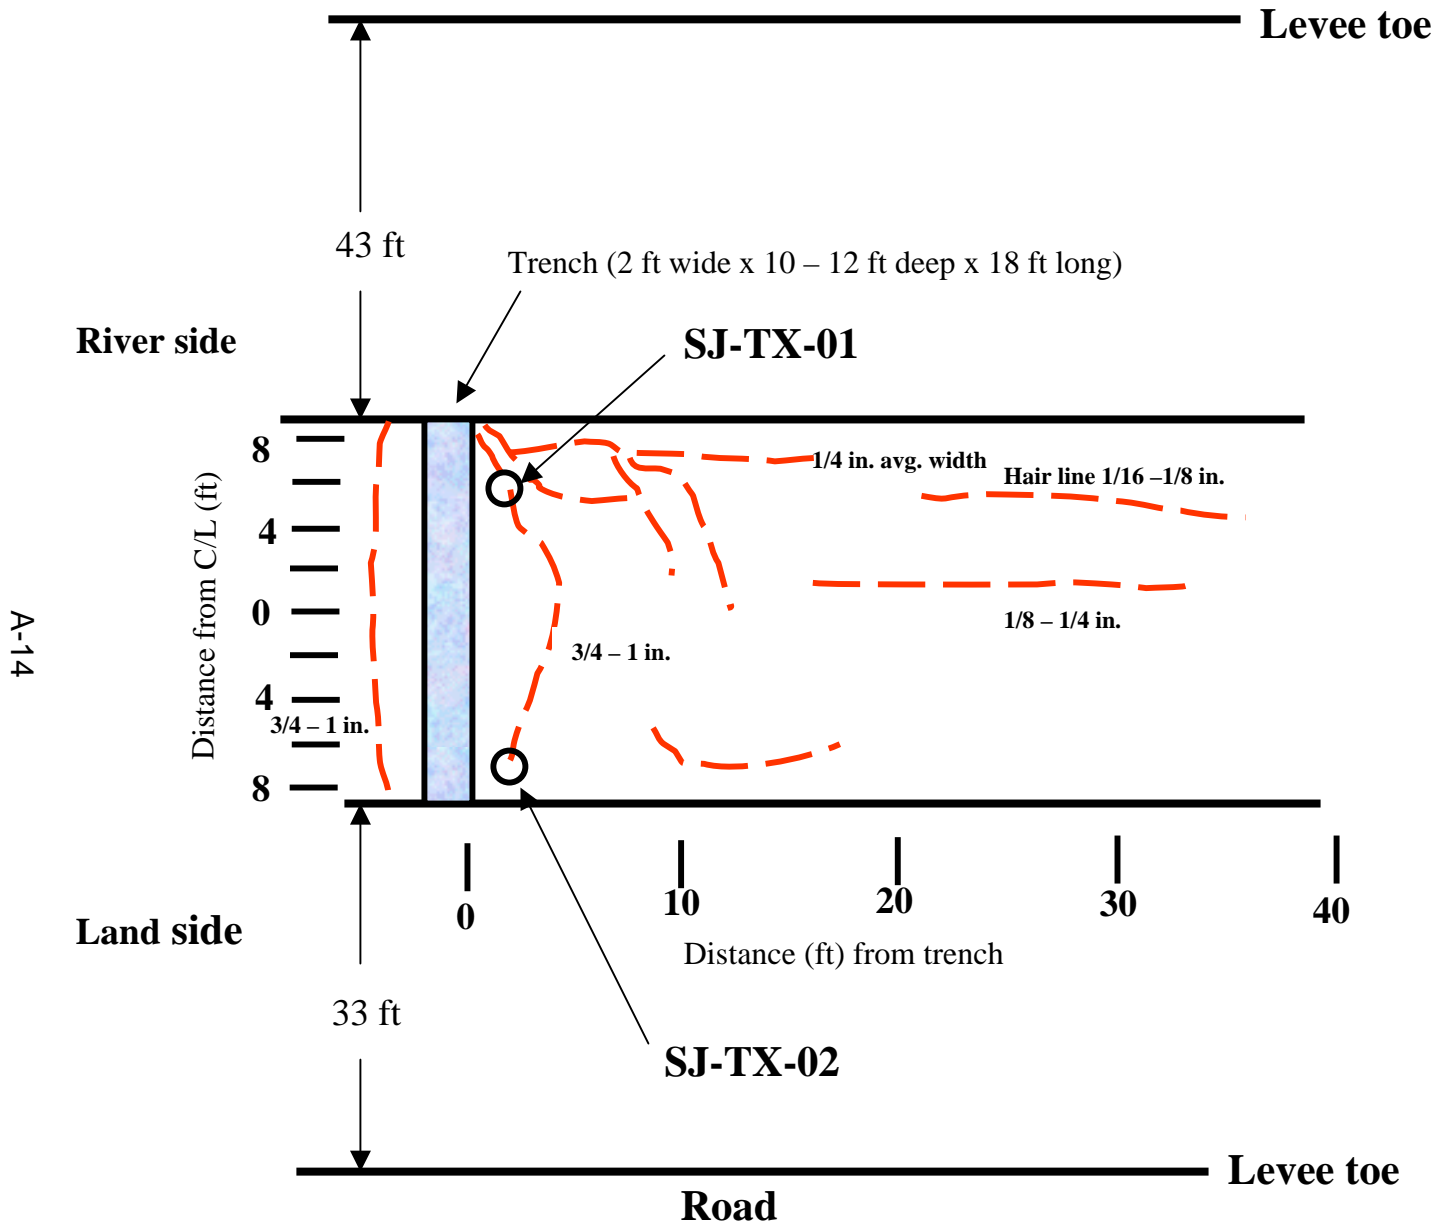
Figure 6. Sketch of cracks on levee road following ponding experiment after 16 hours

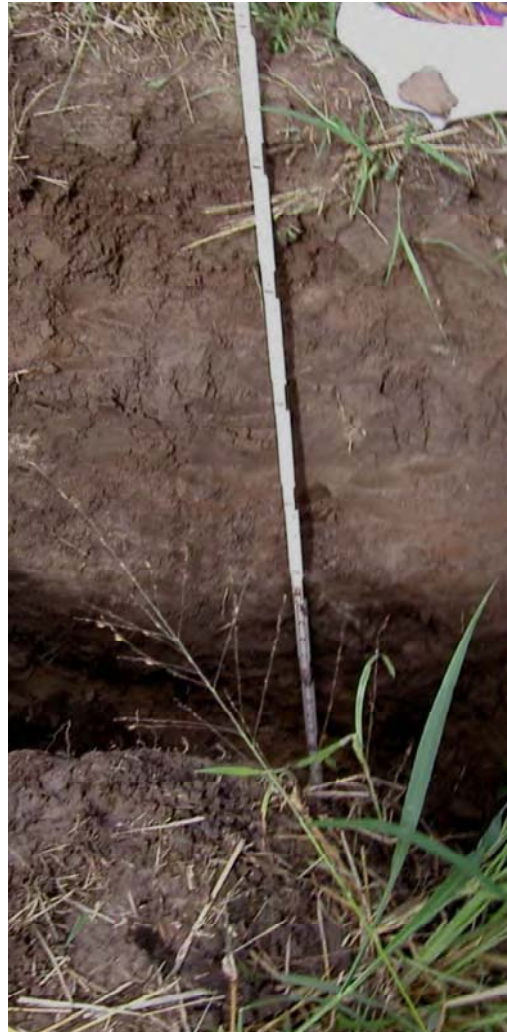
**Station: LS 25**

**Depth: 4.6 ft**

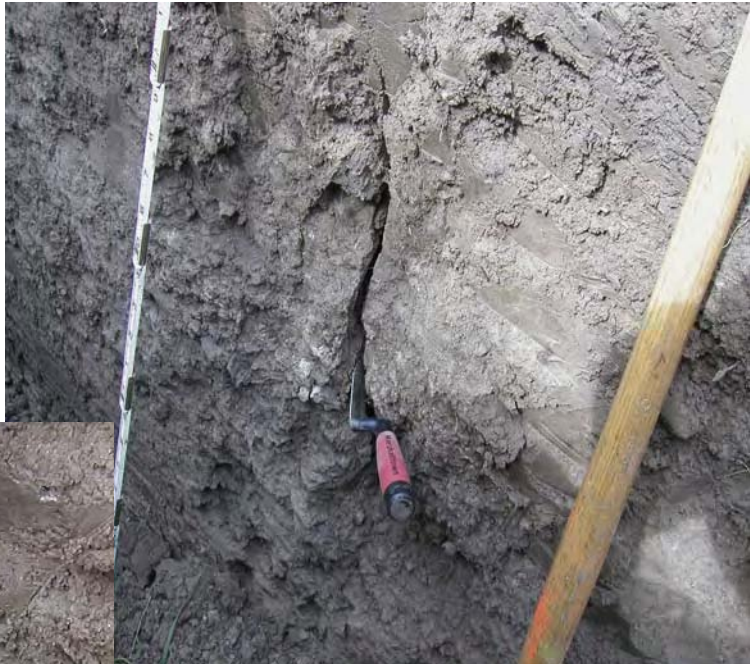
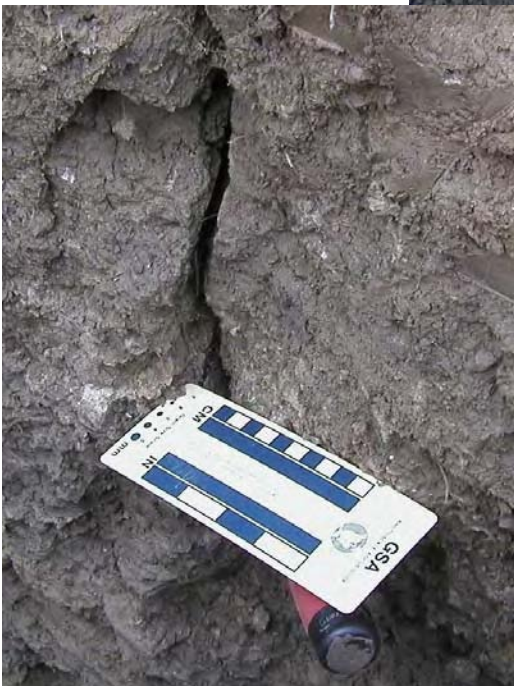
Close up of crack, note blocky texture of soil, and fine sand partings between blocks

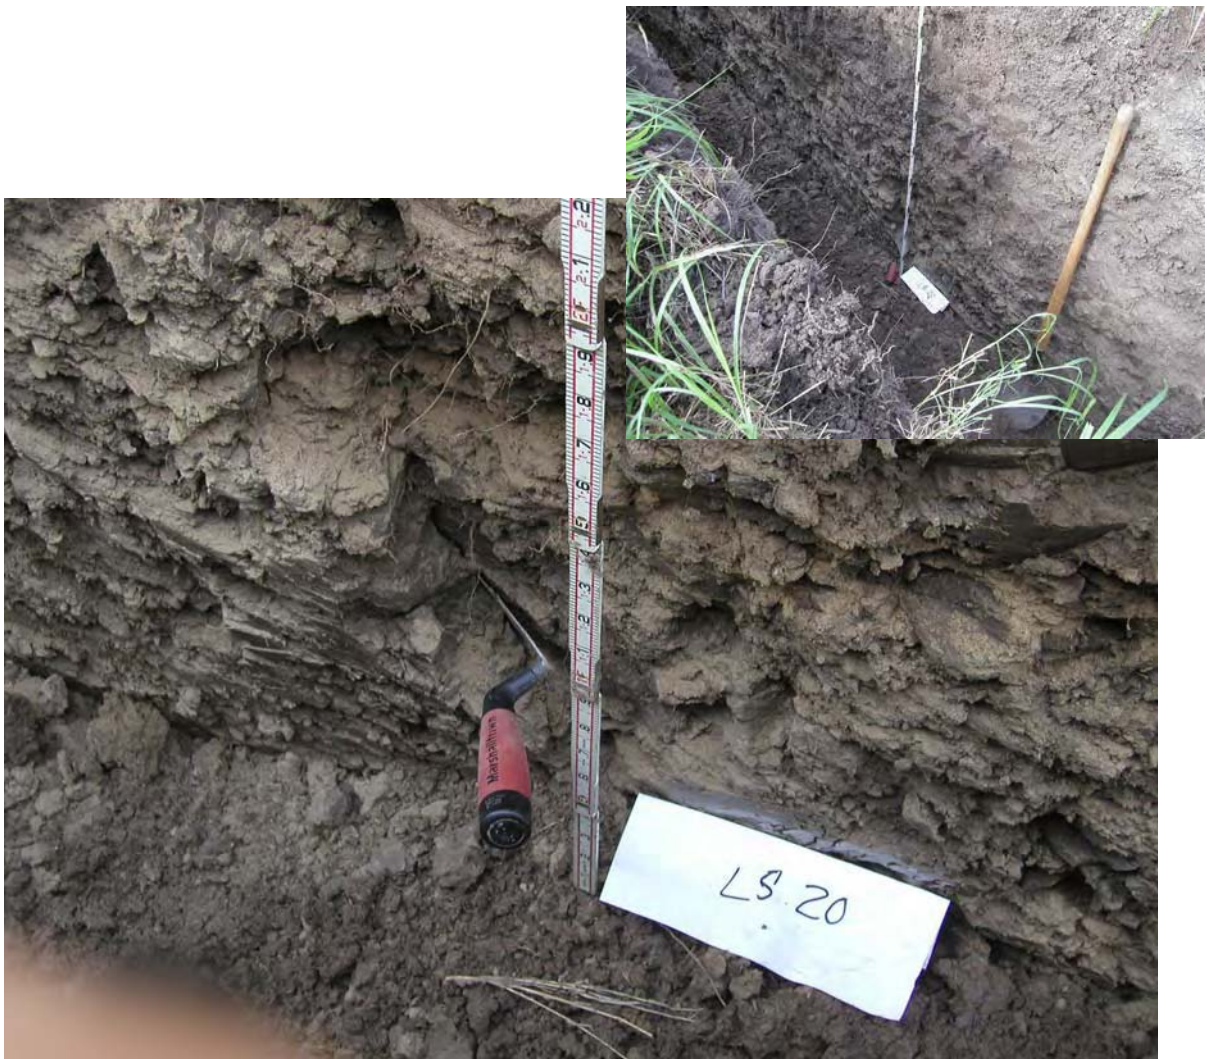
Station LS 20, photograph from 5. to 6 ft, crack near base of trench, note the blocky texture, soil is generally brittle and dry

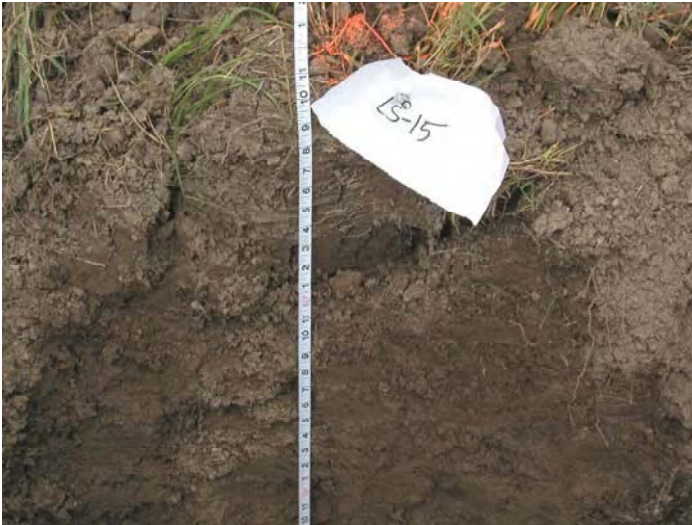
Clay (CL-CH) w. sand (SP) partings, crumbles very easily, brittle, clay ~80-90%, sand ~10-20%, mottled (7.5YR5/6), blocky texture w. sand/silt partings, cracked

Surface to about 2 ft

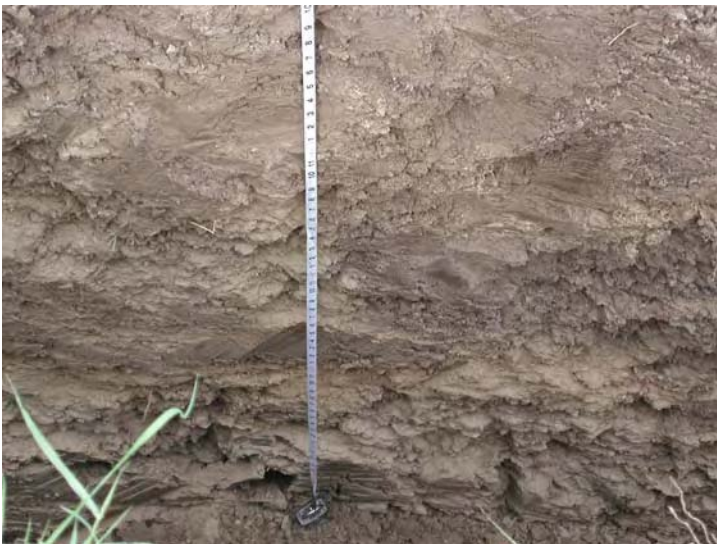
Bottom 2 ft of profile (~ 5 to 7 ft)

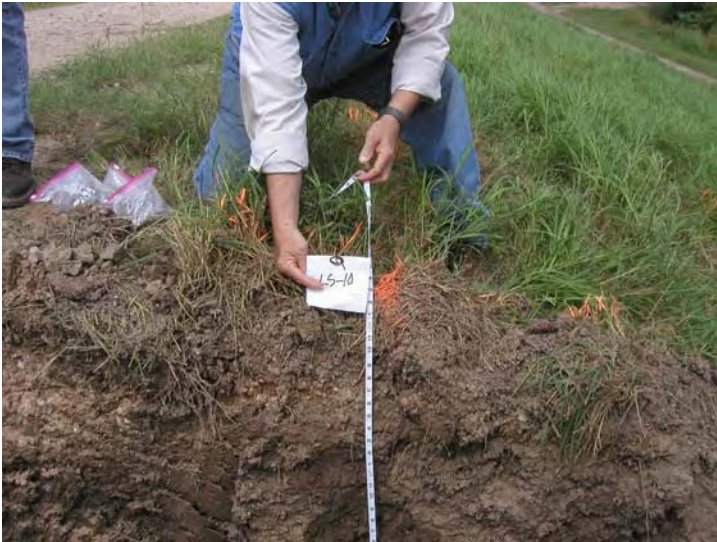
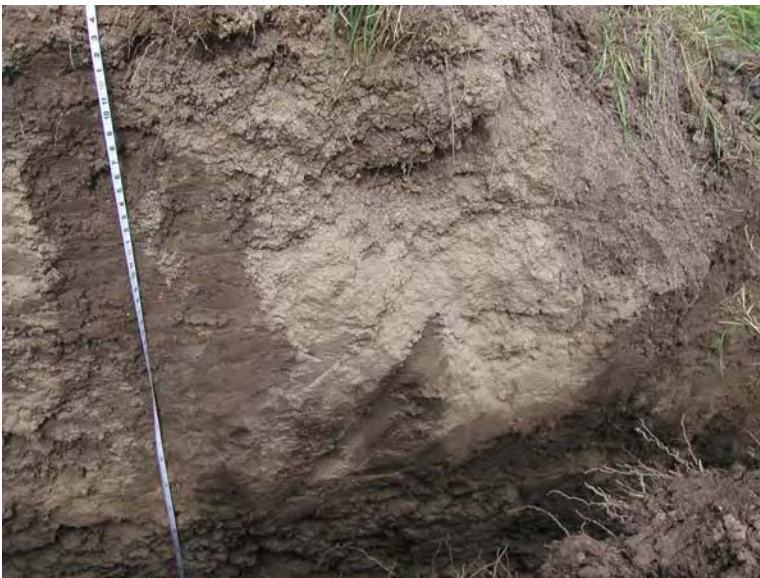
**Station: LS 10**  
**Depth: 10.0 ft**

Depth (ft)	Description
0.0 – 0.75	Roadway gravel
0.75 – 2.5	Clay (CL-CH), organics and roots, damp, slight cohesion, will roll
2.5 – 5.5	Clay (CL-CH), brown (10YR3/3), mottled (7.5YR5/6), damp, soft to stiff
5.5 – 8.0	Clay (CL-CH), same, blocky zone with sand/silt partings, mottled
8.0 – 10.0	Clay (CL-CH), same, damp

Note blocky zone at about  
5.5 to 8.0 ft

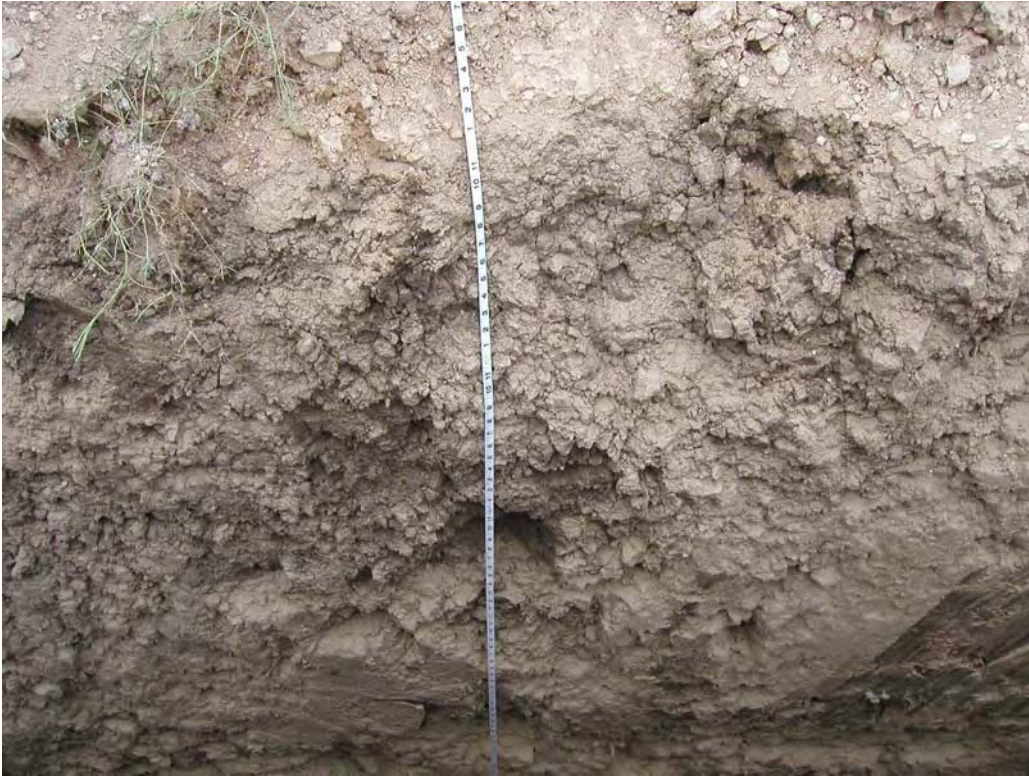
**Station: RS 5**

**Top photo:** view of profile RS 5 from surface to about 4.5 ft. Corresponds to northwest portion of above photo showing different layers in levee core. Note the blocky texture and individual clay pieces or pedon surfaces.

**Bottom photo:** close-up view of blocky clay texture at RS 5, ~ 2 to 3 ft

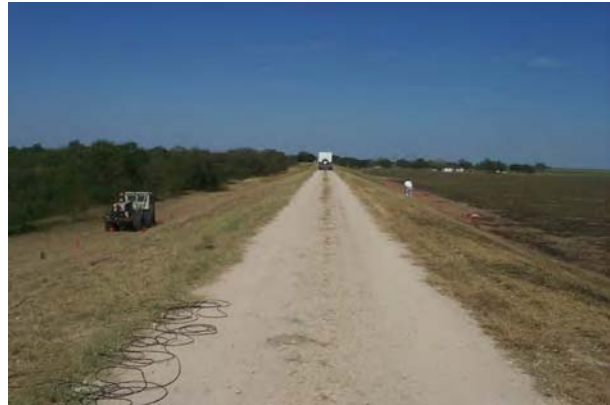
Figure 2. Field site 1 with vibrator on south side of levee, crew working on north side, and semi parked on levee.

Levees along significant expanses of the Rio Grande River in south Texas are currently the responsibility of the International Boundary Water Commission (IBWC). Many of these levees were designed and constructed to minimize or eliminate the threat of the statistically determined 100-year flood event. Newer (1970s era) reaches of IBWC levees were constructed, in some cases, using highly expansive clay materials. Materials used to construct the levees were generally mined from barrow pits in relative close proximity to the active construction area. Therefore, lateral variability in construction materials is common over distances of a mile or less. Average levee height in these areas is about 16 ft with slopes on the order of 1 to 3 (Figure 2).

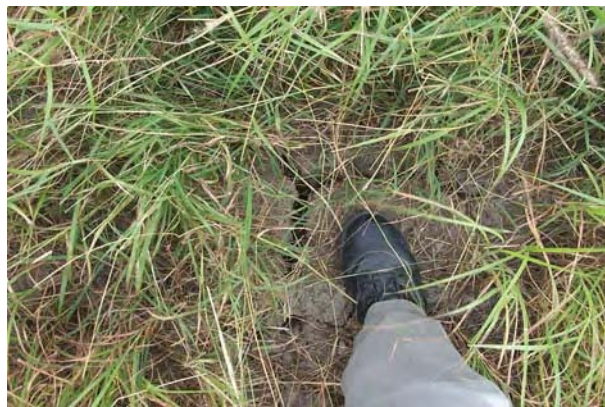
Figure 4. Cracks/fissures evident along the flanks at site 2.

Surface investigations of the slopes and crests at all five sites revealed more evidence of differences in material characteristics. At sites 1 and 2 the conductivity was notably low, and the core samples were clearly less competent than equivalent measurements and samples from sites 4 and 5. Surface investigations at site 1 indicated a much greater concentration of sand to clay than the other sites, a characteristic also evident in cores from this site. At site 2 a higher concentration of surface cracks or fissures were observed both on the crest and along the slopes than at any of the other four sites (Figure 4). A levee core percolation test at site 2 revealed extremely rapid movement of water into/through a trench cut into the levee core.

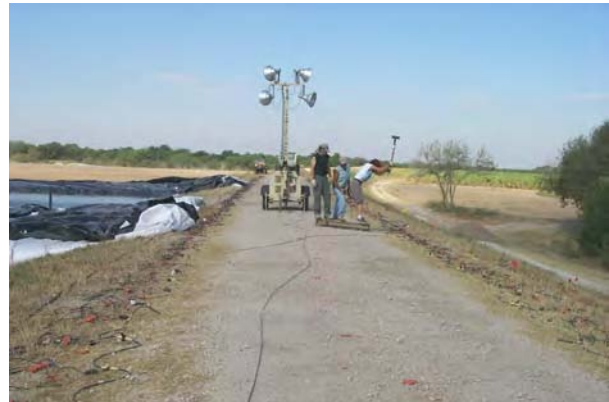
Figure 5. Shear-wave source operated along the north line at site 2 during the ponding test.

It was necessary to understand the arrival patterns of the various compressional- and shear-wave modes during through-levee tomography. At one site two-component data were recorded from a 2-D grid of sources and receivers on opposing sides of the levee (Figure 5). Three-dimensional images highlighted areas within the body of the levee with anomalous velocity characteristics. Integrating the interpretation of the crest 2-D profile and the slope through-levee tomography provided consistent images and allowed confidence in the effectiveness of these techniques. While the emphasis of this effort is on data collection and analysis, modeling is necessary to ensure a thorough understanding of the principal features of the seismograms, and to target those features that are not clearly understood for continued investigation.

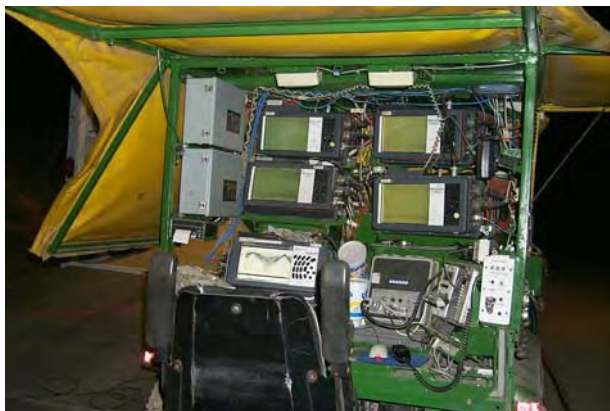
Figure 6. Geometrics 240-channel seismograph mounted in John Deere Gator.

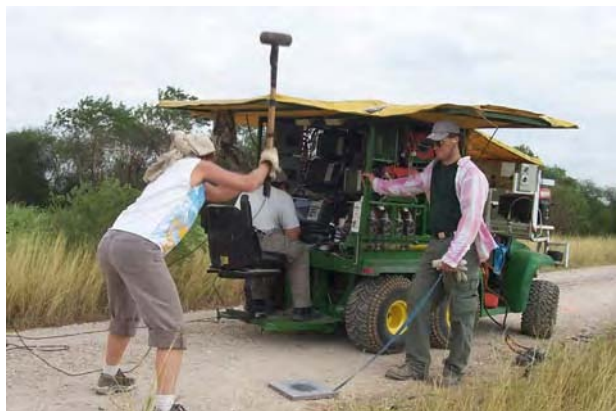
Figure 7. Compressional-wave hammer survey.

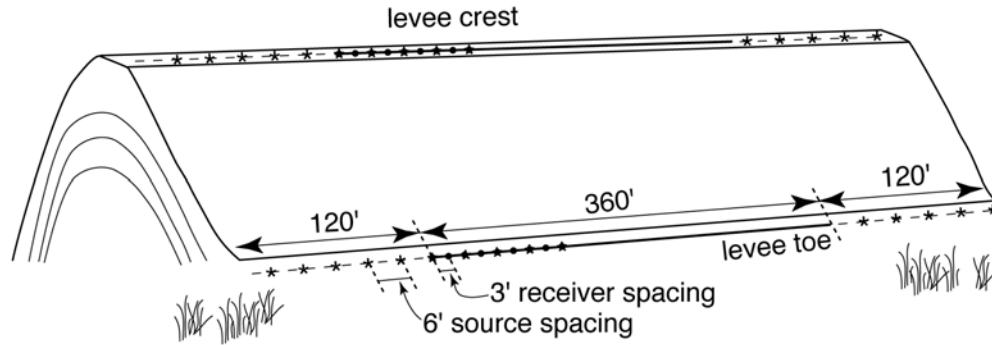
Figure 8. Crest and toe 2-D line deployments.

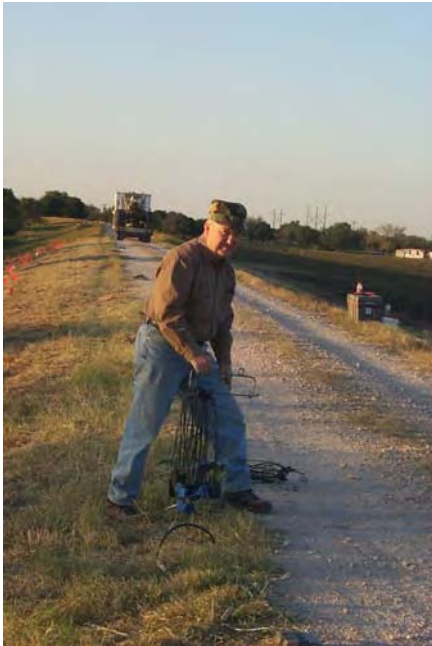
Figure 9. Both compressional and shear geophones were used at each station.

- 2) At each site, one 2-D, 2-C profile was acquired along the crest and at the toe of the levees (Figure 8). Receiver station spacing was 3 ft with two receivers at each location (10 Hz compressional-wave geophones and one 14 Hz shear-wave geophone) (Figure 9). Shear-wave receivers were oriented to be sensitive to motion perpendicular to the axis of the levee (transverse). A 16-lb sledgehammer impacting a striker plate of similar weight for compressional- and surface-wave data (Figure 10) and a 6" x 6" wood block outfitted with steel endplates and serrated earth-coupling teeth (Figures 11 and 12), were used for shear-wave data. The total spread length was 360 ft with 120 channels recording compressional and 120 channels recording shear signals. Source spacing through the spread varied, depending on data quality, from every 6 ft to every 24 ft. Each profile was acquired twice, once with the source in compressional-wave orientation and a second time with a shear-wave source orientation. Data were recorded from shear-wave phones when the shear-wave source was used and compressional-wave phones when the compressional-wave source was used. Stations (source and receiver) were located initially using analog measuring tapes/chain, followed by highly accurate ( $\pm 1$  inch) x, y, and z measurement using a Trimble DGPS surveying system (Figure 13).

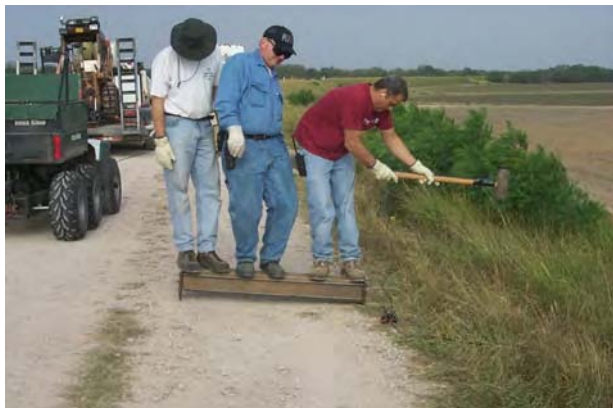
Figure 11. A 1-m-long wood block with steel end plates held down by standing on top of the block was used to generate shear energy.

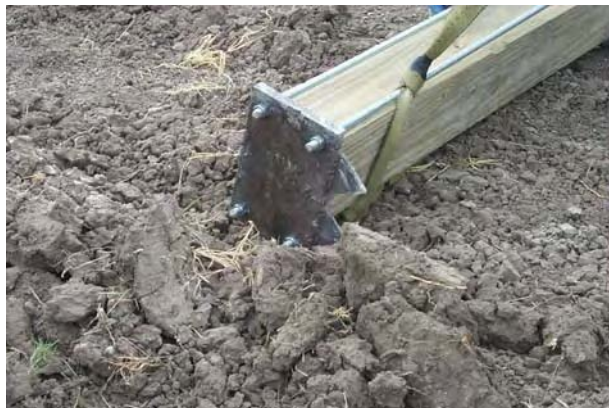
Figure 12. Steel teeth were forced into the ground to minimize source decoupling and sliding along ground surface.

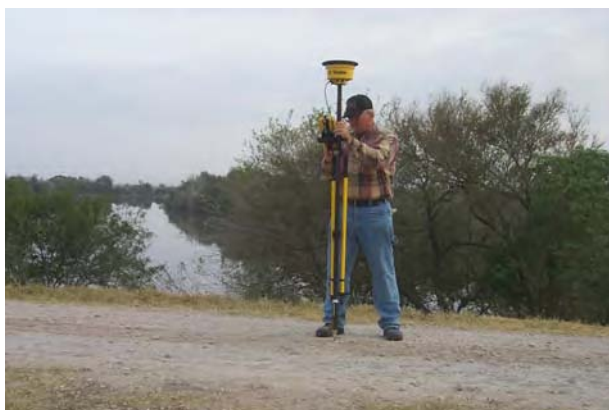
Figure 13. Differential Global Position System (DGPS) was used to accurately locate all sources and receiver stations.

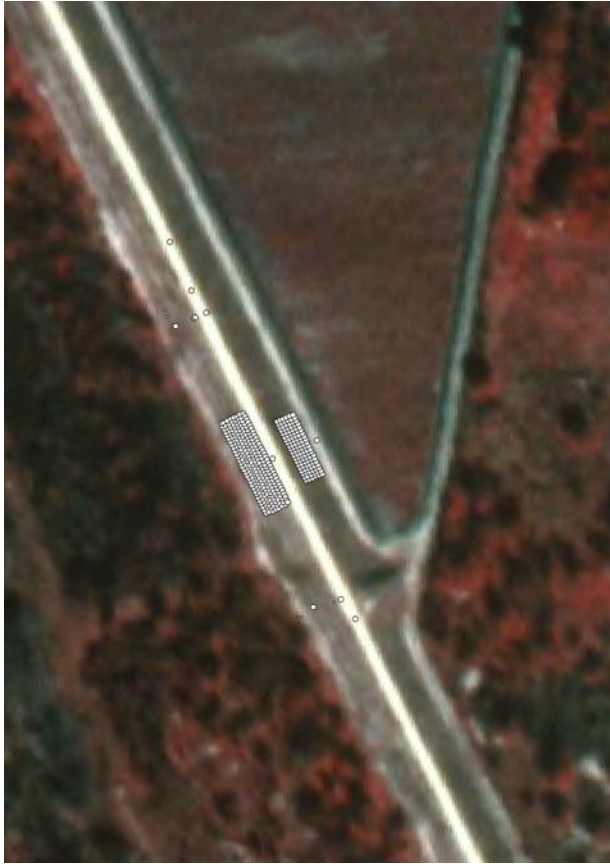
Figure 14. Through-levee receiver and source grids at site 1.

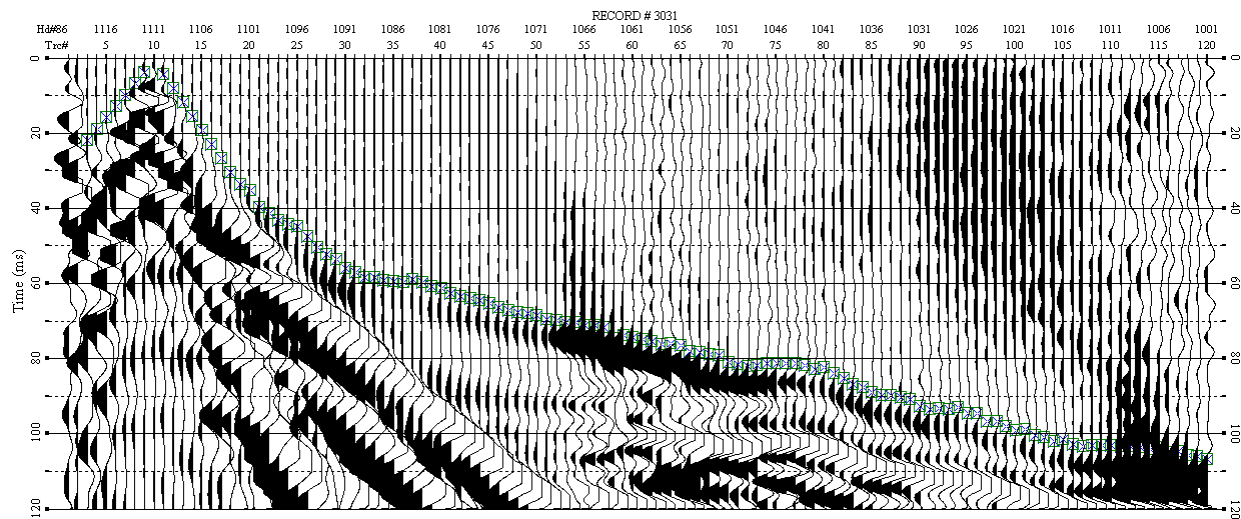
Figure 44. Estimation of first-arrivals times on a P-wave seismic data with source located at station 1111 (horizontal coordinate at 3333 ft).

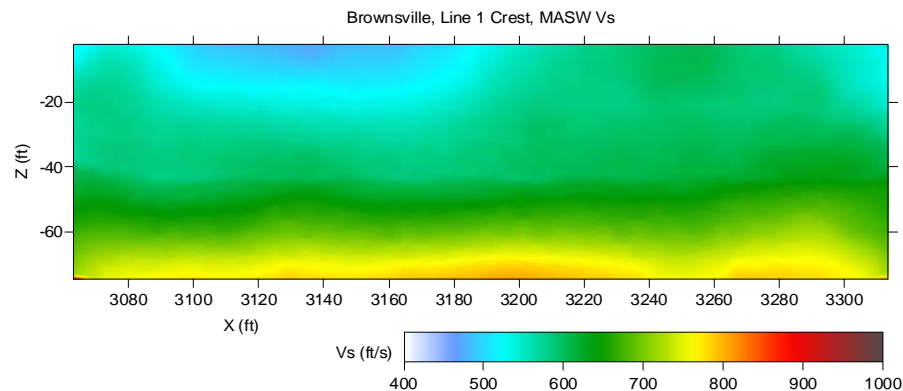
Figure 57. S-wave velocity model estimated for line 1 by analyzing P-wave-data surface-wave using MASW method.

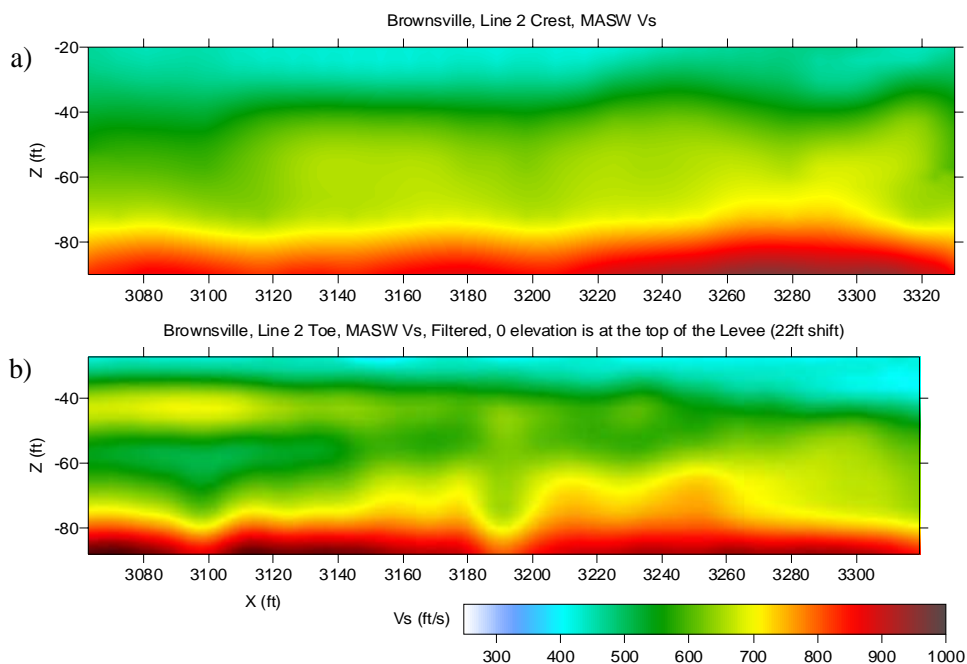
Figure 95. Line 2 S-wave velocity model estimates by analyzing P-wave-data surface-wave using MASW method, a) at the crest of the levee, b) at the toe of the levee.

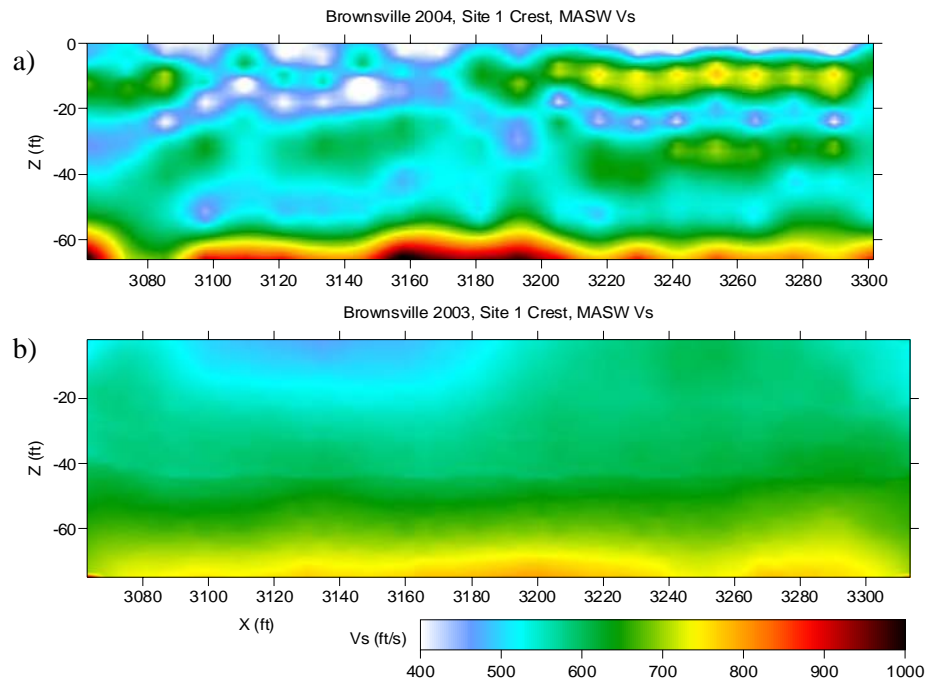
Figure 122. S-wave velocity models estimated at the crest of the levee at site 1 by analyzing P-wave-data surface-wave using MASW method acquired in, a) S-wave velocity model obtained from the seismic data acquired in 2004, b) S-wave velocity model obtained from the seismic data acquired in 2003.
